Structural Engineers Report For:

Westwinds, St Andrews Road, Dinas Powys,
CF64 4HB

VISUAL INSPECTION REPORT

REF: 19305

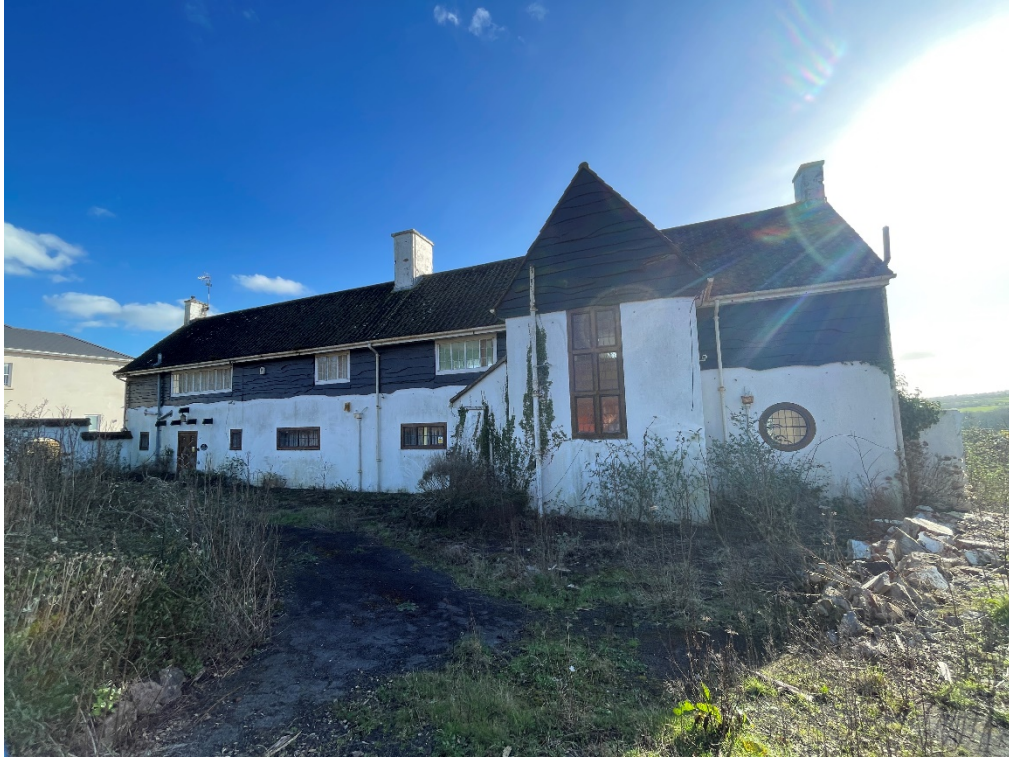
- 2.1. External inspection of the above property revealed an obvious lack of maintenance to the main property and outbuildings, which was evident with the overgrown vegetation and condition of the property finishes. See photographs 1, 2 & 3.

Photograph 1 – Front elevation

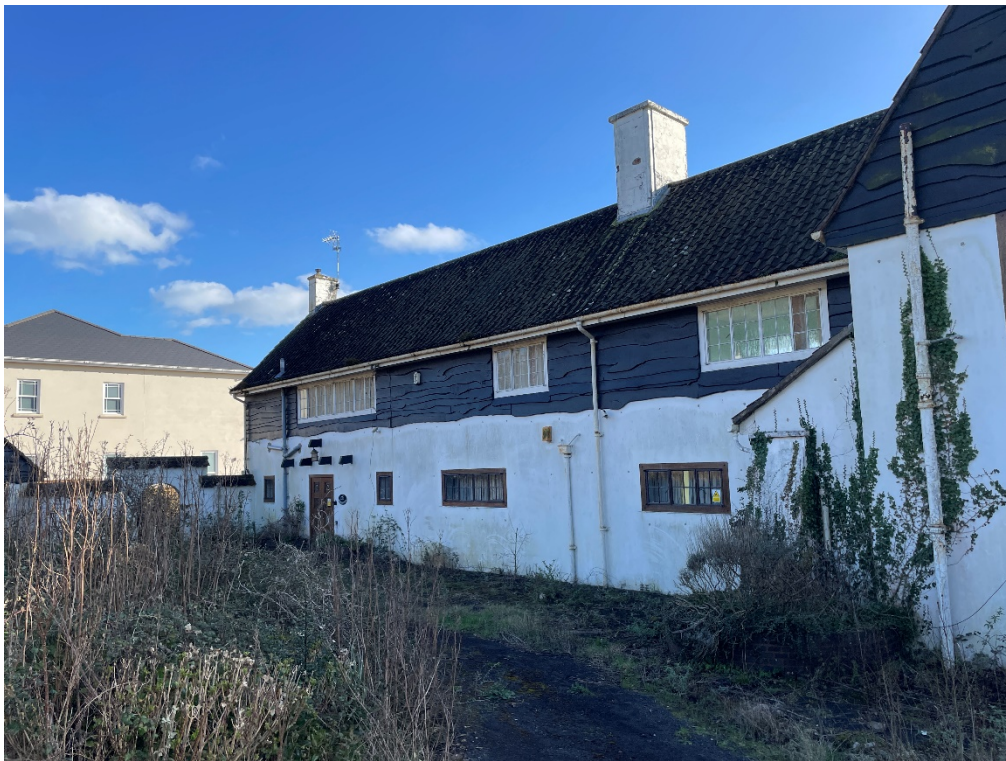
Photograph 2 – Front elevation

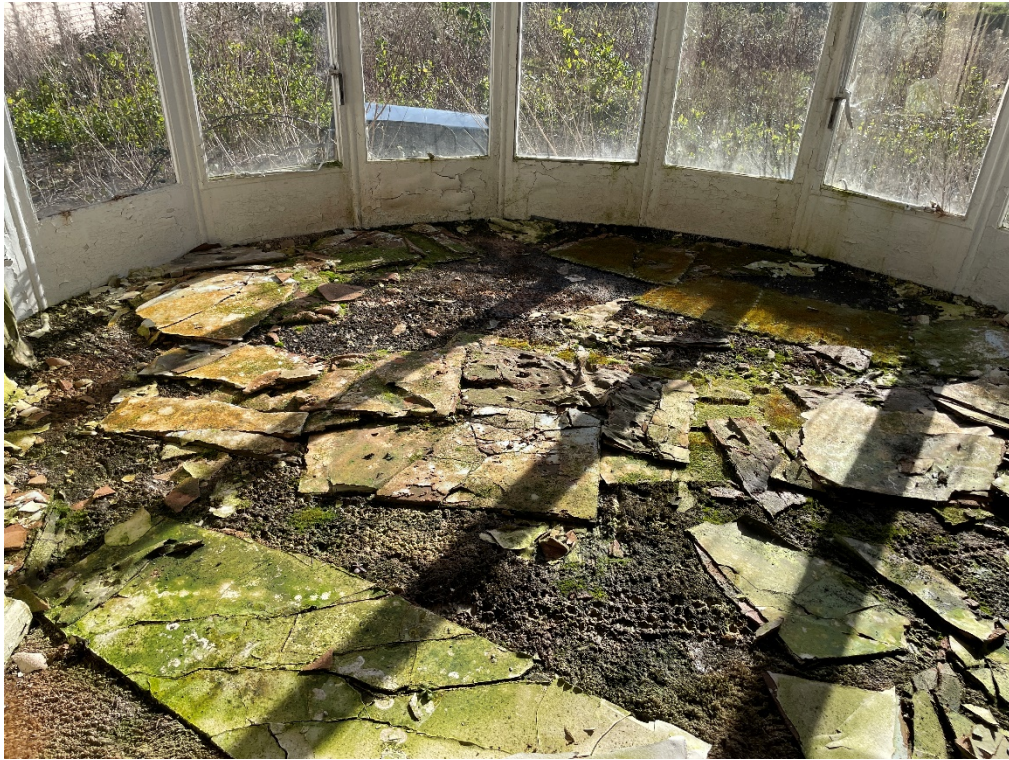
Photograph 3 – Poor condition of rear sun room

- 3.4 The rear conservatory was in a poor state, and will likely require extensive work to repair. Existing timber joists appear to be damp in areas which will likely need replacing. The existing floor needs to be cleared of all debris and material, to expose the slab below. It is highly likely that the floor will need to be re-laid with a new concrete slab or timber floor joists.

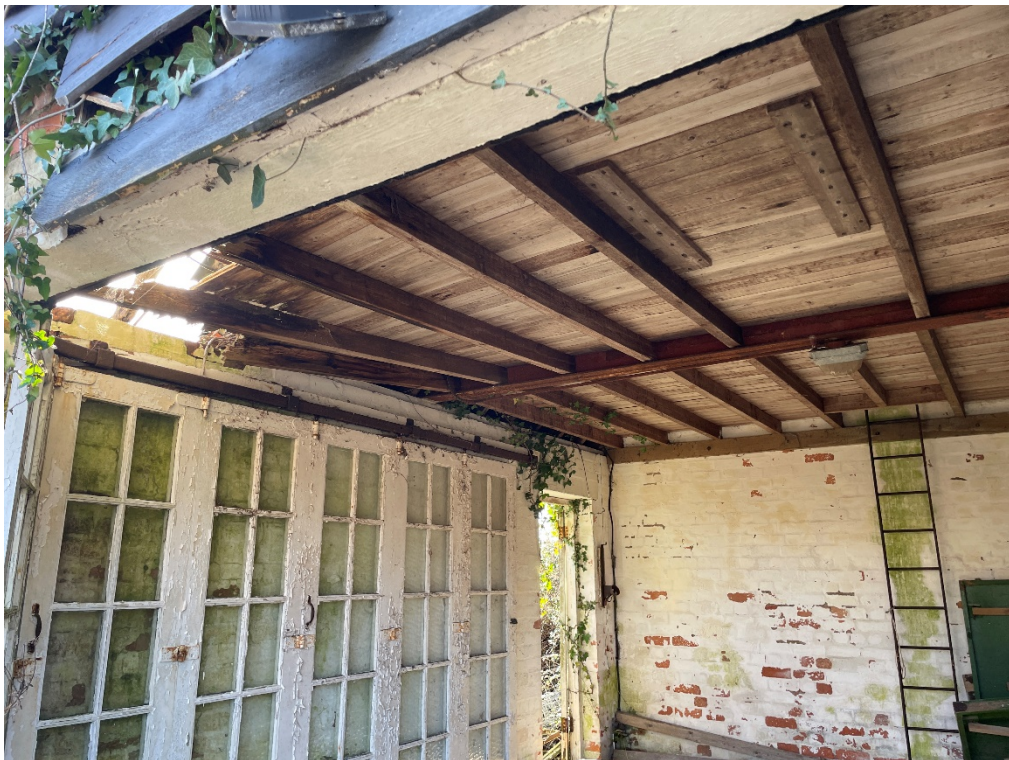
- 2.2. Existing timber floor joists and timber rafters in the two outbuildings were noted to be in a state of disrepair and were no longer in suitable condition. Timber joists and rafters have areas of damp at the bearing points, which has caused the timber to fail. See photographs 4 & 5.

Photograph 4 – One of two outbuildings to front of property

- 3.2 The outbuildings to the front of the property require replacement of floor joists and timber rafters in areas, which will allow there to be a habitable space at first floor. Existing steel beams did not display any signs of distress or excessive deflection, although will require to be assessed if the first floor is to be used as a habitable space.

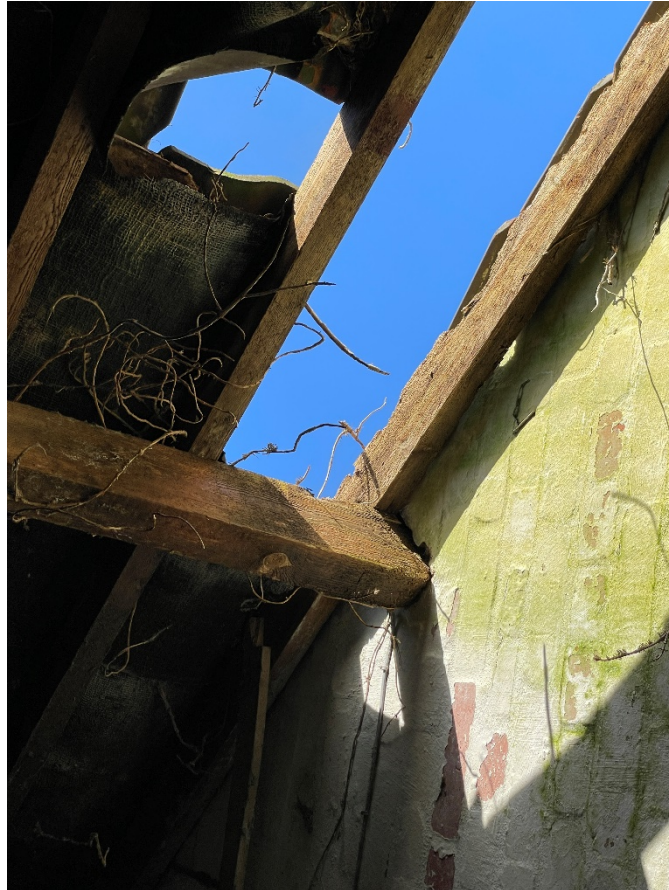
Photograph 5 – Poor roof condition in outbuildings

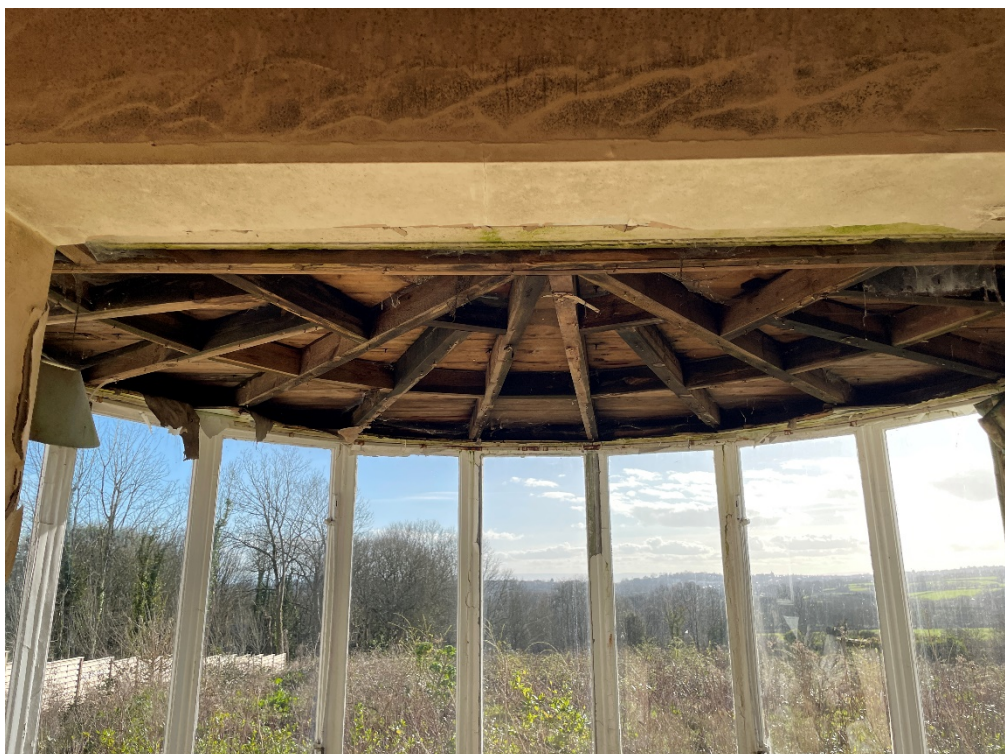
- 2.3. Exposed timbers to the rear of the property, where the conservatory butts up to the main property, were majorly rotten and are no longer in a suitable condition. The existing floor in the conservatory was wet to the touch, with vegetation and severe damp areas noted. There was vertical cracking at the masonry reveal into the conservatory, approximately 2-3mm in width. See photographs 6 & 7.

Photograph 6 – Rear sun room timbers

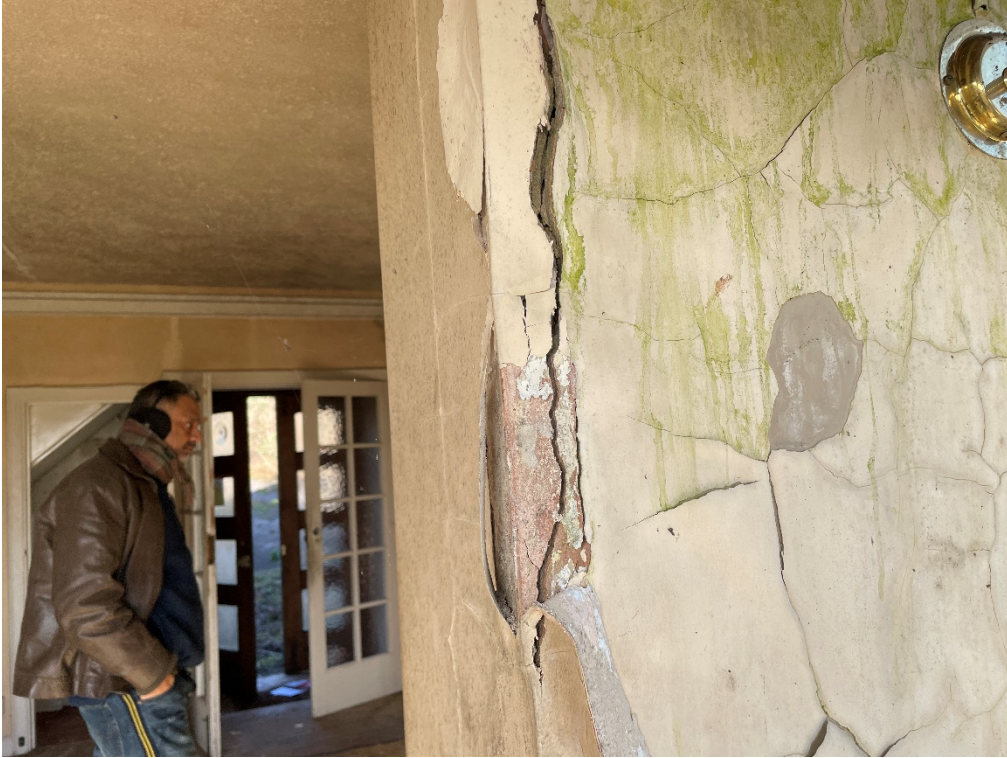
Photograph 7 – Vertical cracking into rear sun room

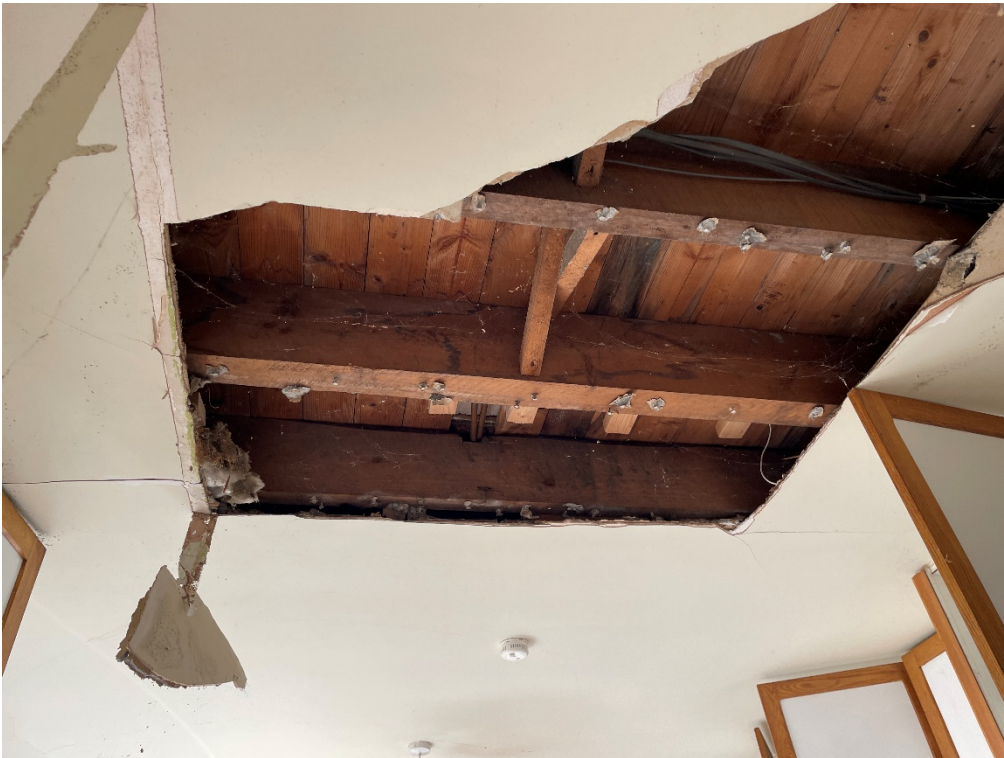
- 2.4. The existing ground floor was noted to be suspended timber floor joists, which were visible in the living area. There was an approximate 400-500mm void beneath the timber floor joists, and exposed timber floor joists appeared to be in satisfactory condition. See photographs 8 & 9.

Photograph 8 – Exposed first floor timber joists

- 3.6 No issues were noted with the ground floor or first floor timber joists, although the entirety of the floor was not exposed.

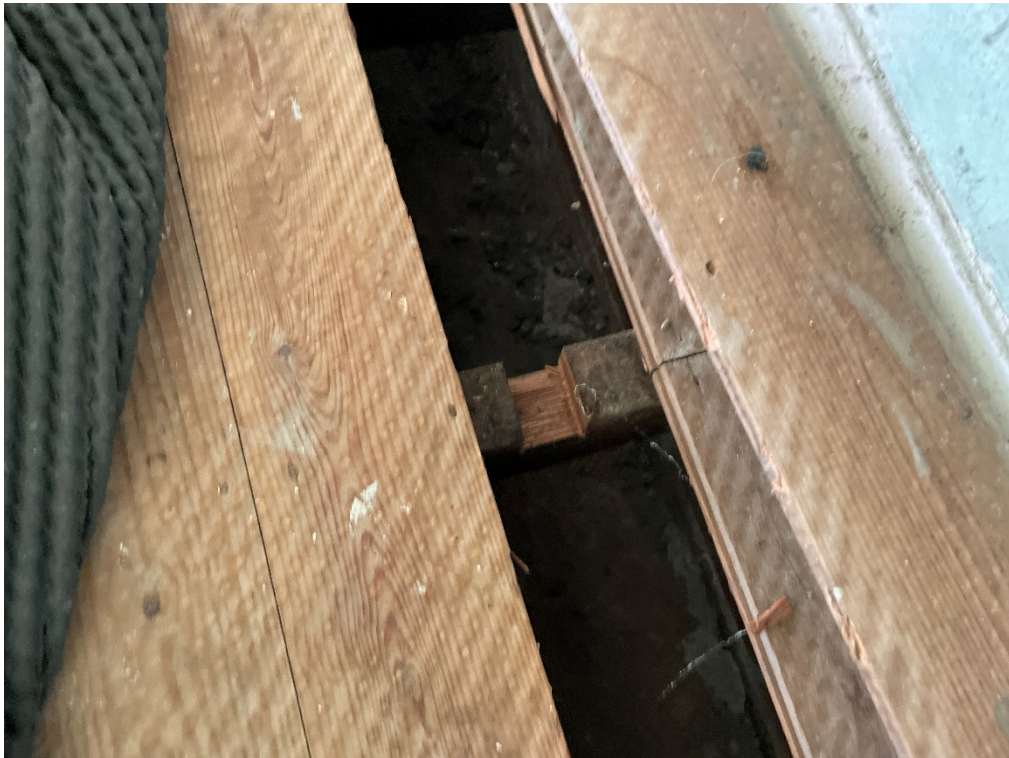
Photograph 9 – Suspended ground floor timber joists

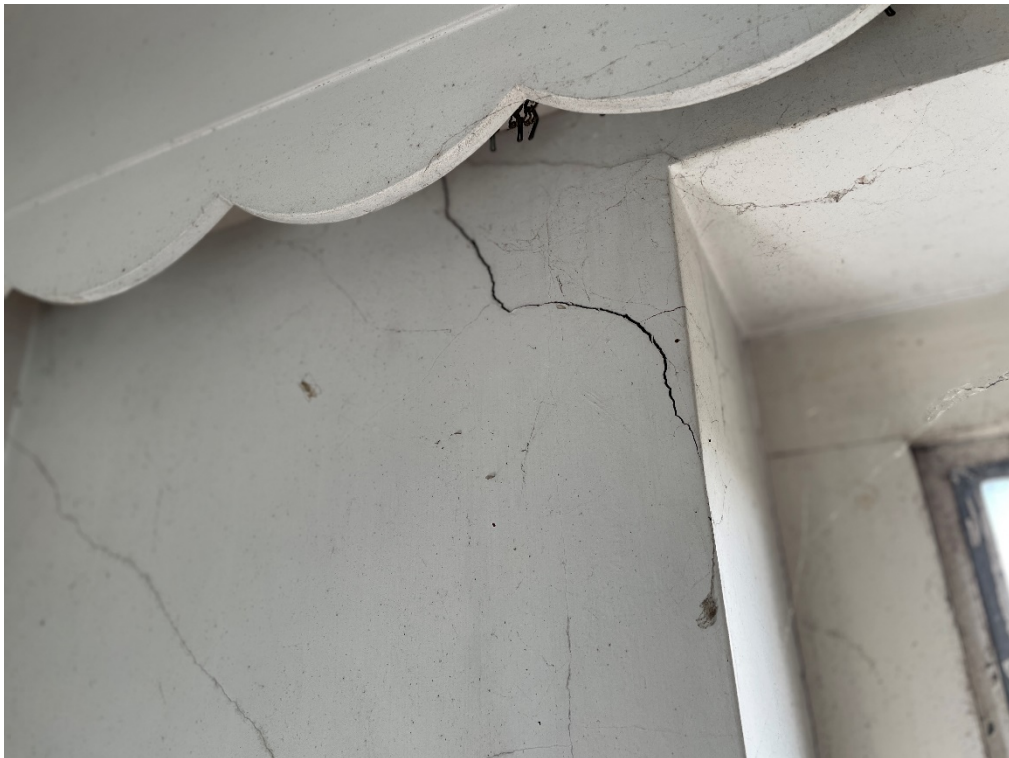
- 2.5. Minor hairline cracking was noted over a number of doorways at ground floor, which were approximately 2-3mm in width and were localised above the doorway only. See photograph 10 & 11.

Photograph 10 – Diagonal cracking over doorway

- 3.5 We recommend that internal wall finishes are removed throughout the property to assess the condition of the masonry. This will also allow cracking over door heads to be assessed, to determine whether existing lintels need replacing. No cracking was present externally indicative of ground movement, which suggests that internal cracking is the result of diminished finishes or lintels. If cracking has continued through into the brickwork, we recommend stainless steel helical bars are introduced at max. 450mm vertical centres, to reinstate the structural integrity of the masonry.

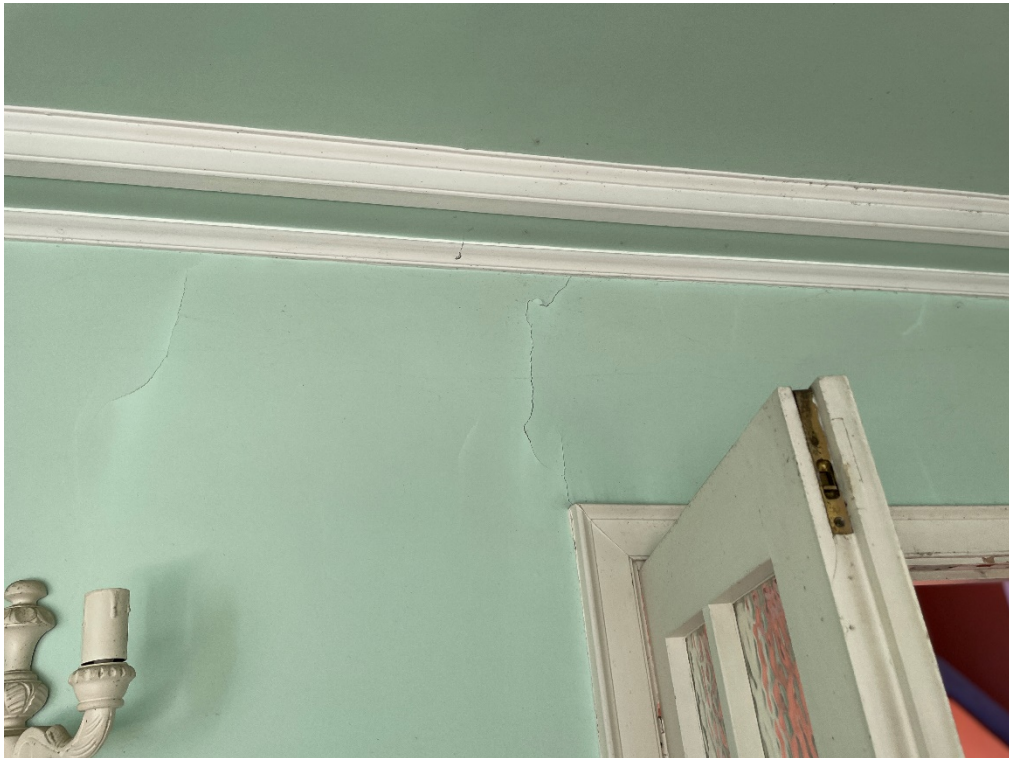
Photograph 11 – Vertical cracking over ground floor doorway

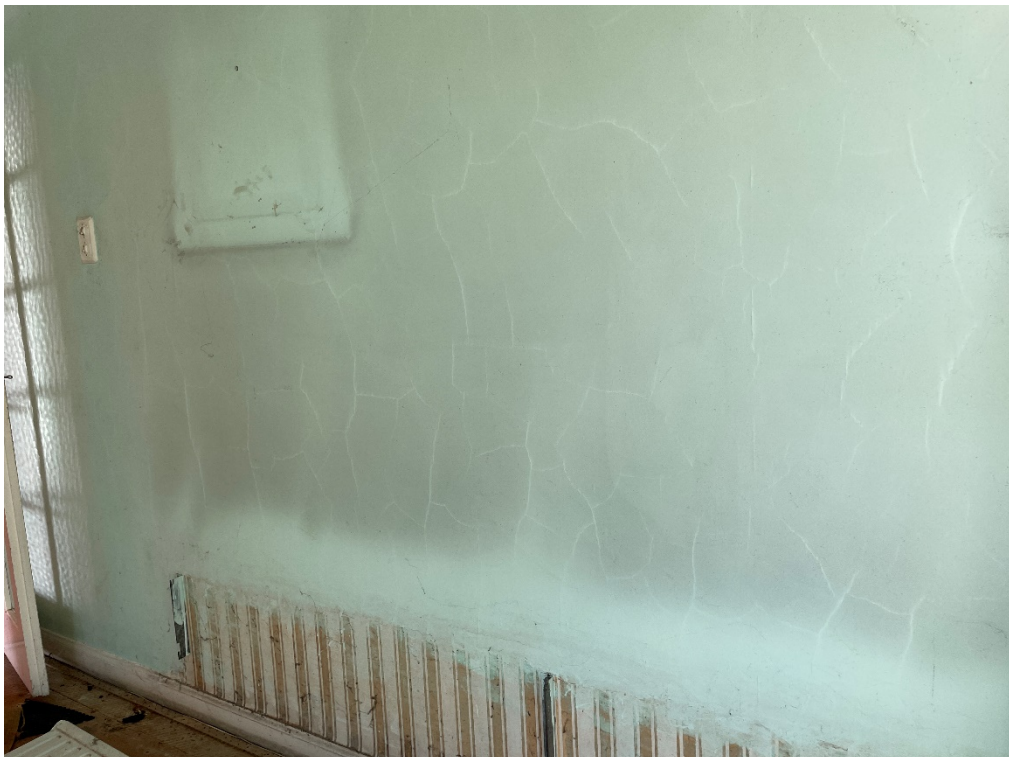
- 2.6. Various cracks were noted to the internal face of the external walls, which are likely cracks within the internal finishes. See photograph 12.

Photograph 12 – Cracking to internal face of external walls

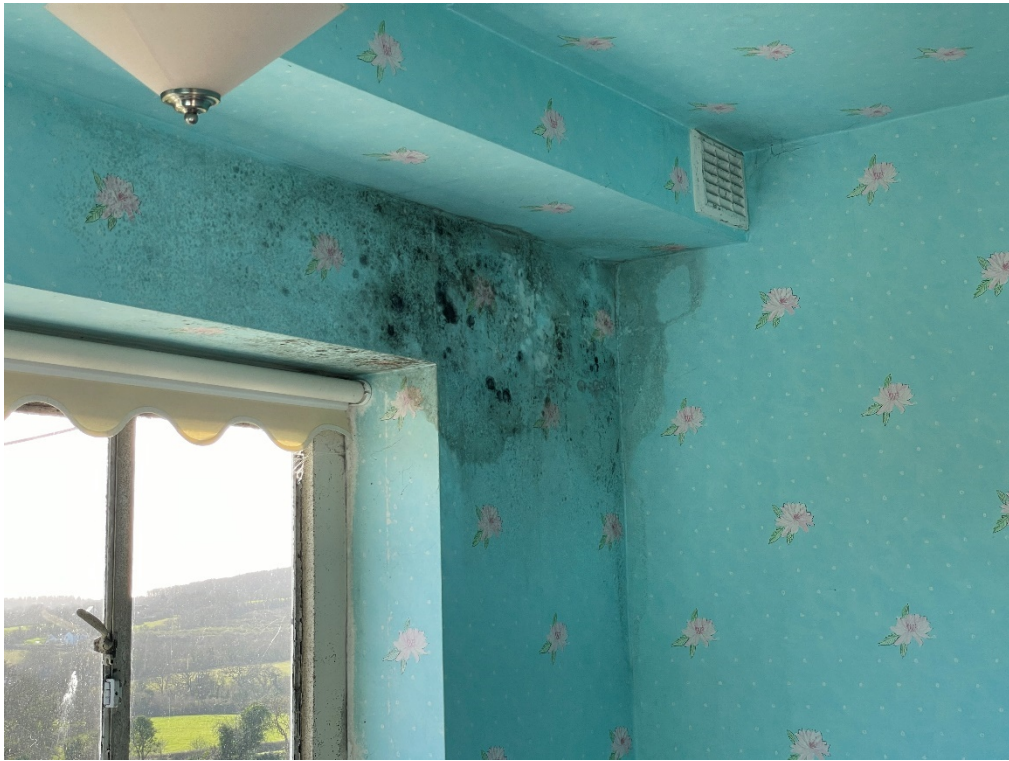
- 2.7. At first floor, various cracks were noted to the internal face of the external walls, which are likely cracks within the internal finishes. These cracks were hairline up to 2mm in width.
- 2.8. Damp issues were noted at first floor level at various window reveals, which likely correlates with damages to the external cladding. See photograph 13.

Photograph 13 – Damp areas throughout the property

- 3.3 External cladding is to be made good in areas to avoid water ingress into the interior building, which is likely the cause of damp noted throughout the property. Water ingress through the external walls may also result in cracking of masonry and wall finishes.
