Bat Survey: Westwinds, St Andrews Road, Dinas Powys, Vale of Glamorgan, CF64 4HB

Reported by: Ecological Services Ltd
10 Mount Pleasant, Llanelly Hill, Abergavenny, Monmouthshire, NP7 0NT

Author	Date	Version
Rich Watkins	June, 2021	V1.0

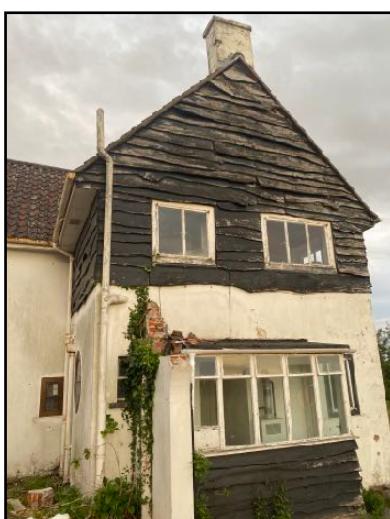
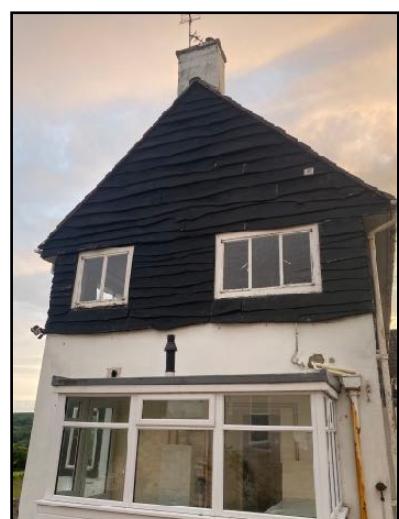
2.1 The property consists of the main house, with two garages to the front of the property and a stable block to the rear of the property. The property is detached. The main building is large in size and is partly sand cement rendered and partly wood clad. The building consists of a tiled, apex roof with a tiled ridge and three brick rendered chimneys. There are numerous windows on the building. There is a small flat roofed conservatory to the rear of the building and two flat roofed extensions; one to the left side of the building and one to the right side. The building has two storeys. There is wooden fascia and soffit all around the building. There is a cavity wall in the building. There is a tiled, lean-to extension to the front of the building which acts as the entrance to the building. Neither the main building or any of the outbuildings are currently in use.

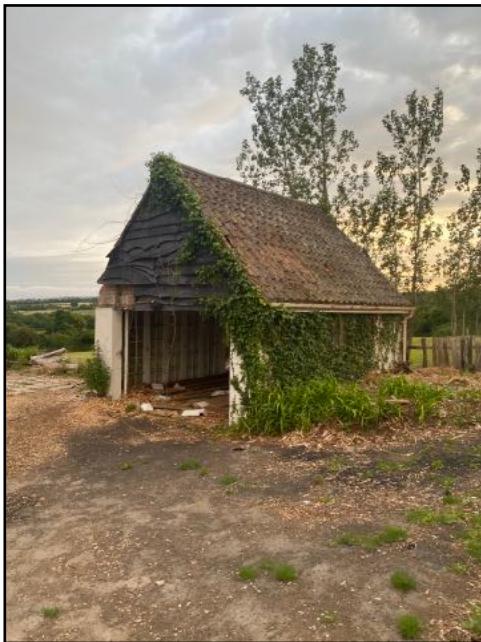
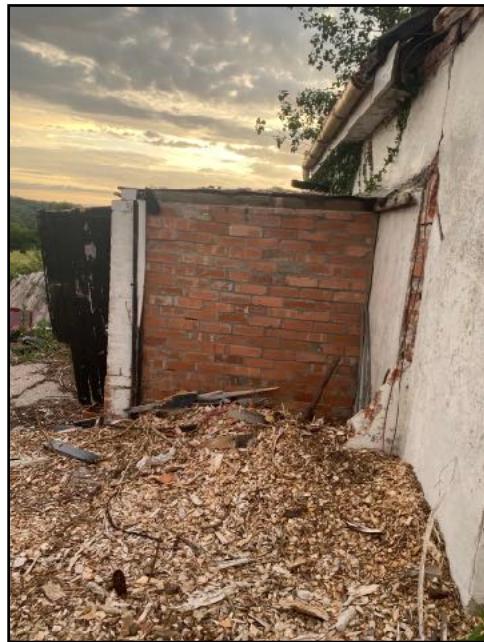
There is a detached, two storey garage to the front right of the main building. The garage is brick with sand cement render and a tiled, apex roof. There are no chimneys on the garage. The top of the garage is partly wood clad. The garage has an open front; a single window and a single side door. There is a loft in the garage. There is no cavity wall in the garage. There is a separate flat, plywood roofed extension block to the left side of the garage with two open doors.

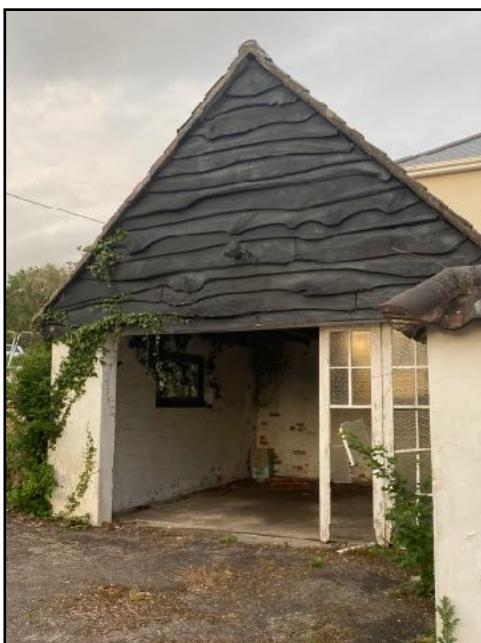
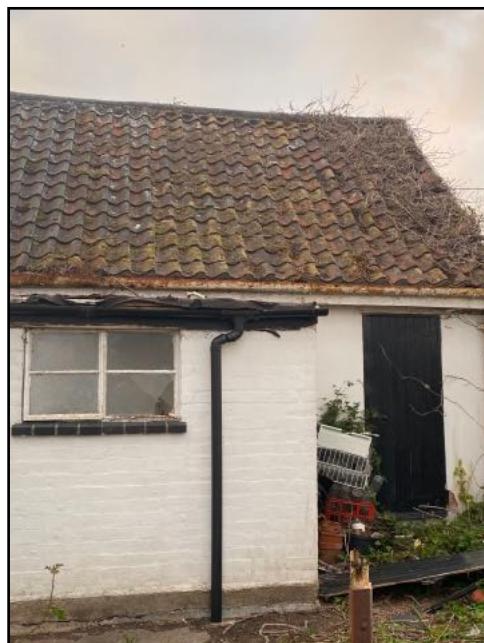
There is a detached, two storey garage to the front left of the main building. The garage is brick with sand cement render and a tiled, apex roof. There are no chimneys on the garage. The top of the garage is partly wood clad. There is wooden fascia and soffit all around the garage. There is a loft in the garage which could be seen from inside. The inside of the garage has a vaulted ceiling which consists of felt on top of timber trusses. There is an open front to the garage; a single window and a single side door. There is no cavity wall in the garage. There is a separate flat, plywood roofed extension block to the right side of the garage with two closed, wooden doors and one open front. There is wooden fascia on the extension block and no soffit. One of the sections of the extension block was used as an outdoor toilet.

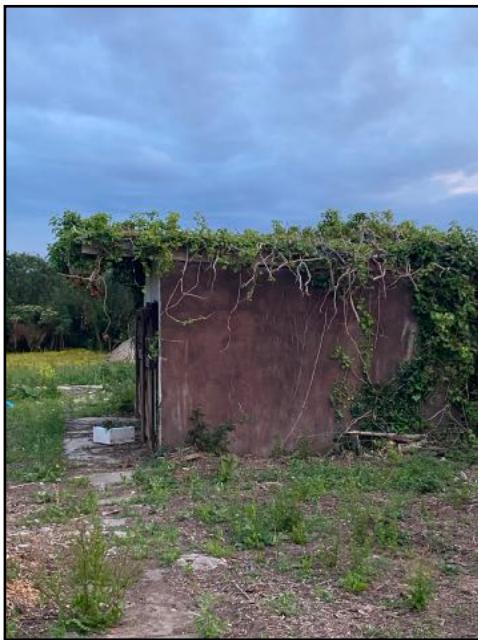
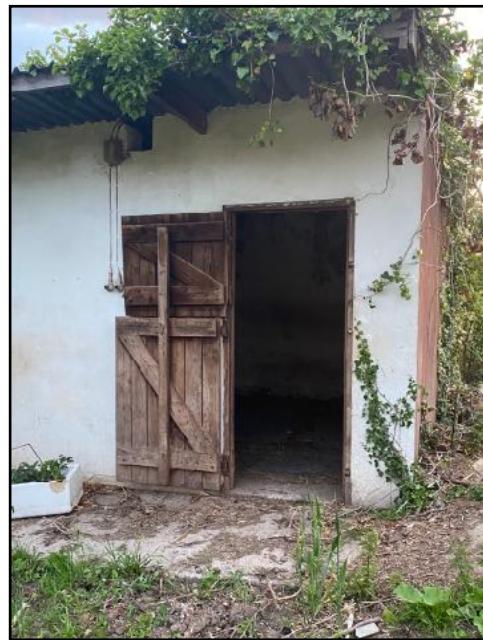
There is a detached, single storey stable block to the rear of the property. The stable block is block built on a hardstanding and sand cement rendered. There is a flat, tin sheet roof on the stable block. There are timber stable doors to the front of the building. There is no cavity wall in the stable block.

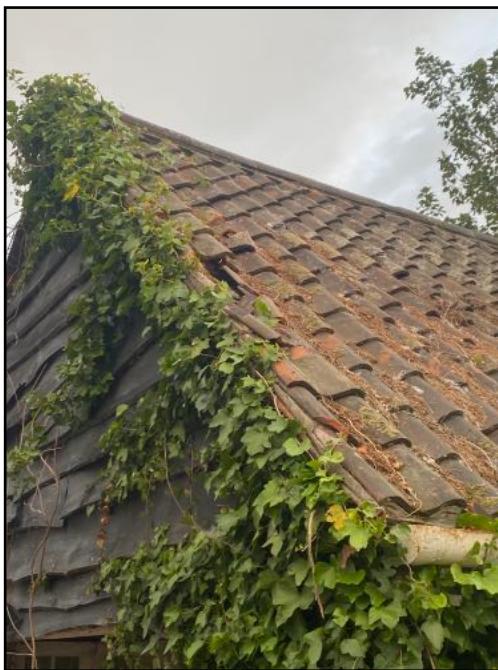
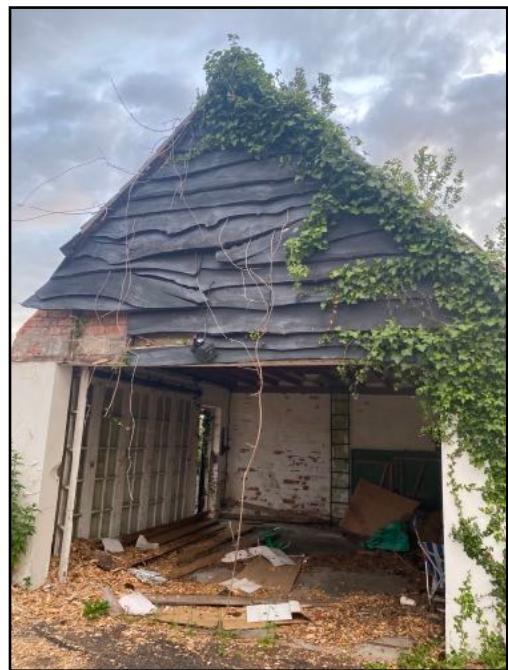
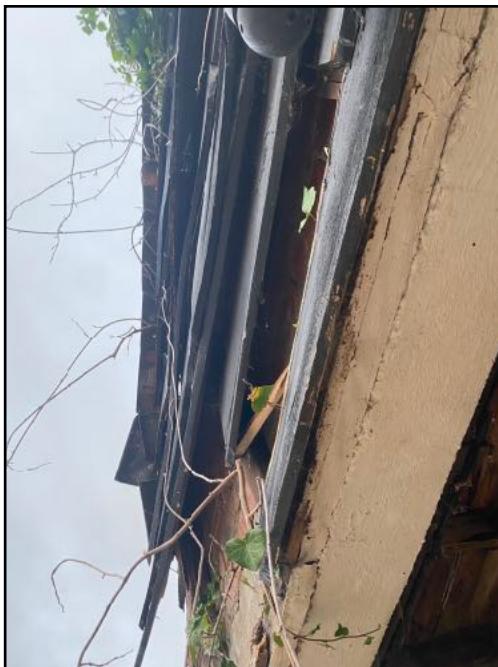
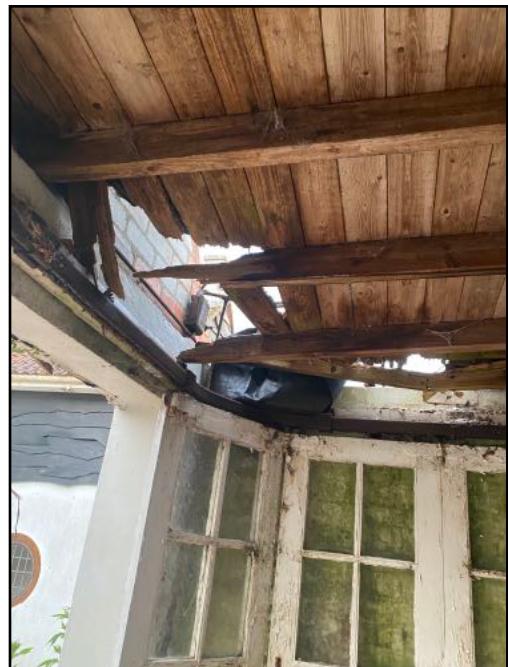
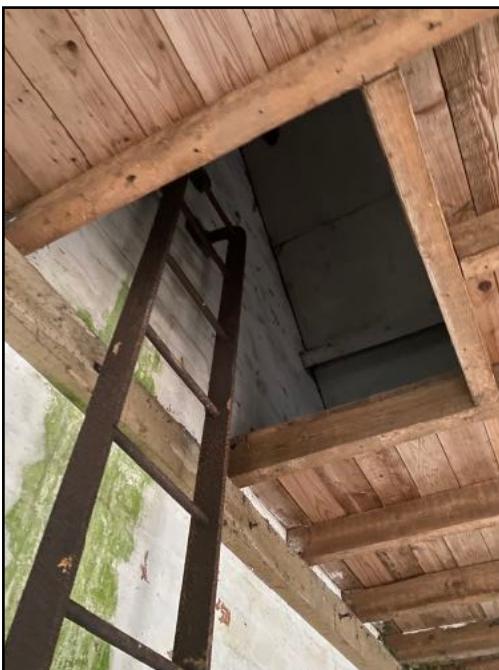
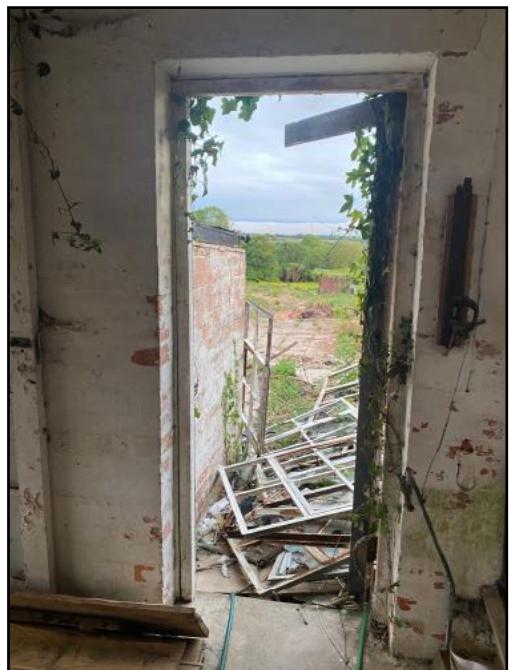
6.5 Examples of apertures allowing access to cavities in the buildings:

6.3 Due to the condition of the buildings, there were a high number of opportunities for bats to access and use the buildings. Those that were available were deemed as high potential and the buildings were classed as high potential for roosting bats.

Potential Features for Bats to Access and Use the Buildings			
Main Building	Front Left Garage	Front Right Garage	Stable Block
Gaps in the Wood Cladding	Gaps in the Wood Cladding	Raised Roof Tiles	Open Timber Doors
Holes in the Right Gable End Wall (Sand Cement Render)	Missing Tiles on the Roof	Gaps in the Wood Cladding	Gap where the Roof Meets the Building
	Raised Roof Tiles	Missing Timbers in the Loft Floor	Missing Sheets off the Roof
	Gaps in the Felt in the Loft	Disused Loft	Gaps Between the Timber and the Building
	Missing Timbers in the Loft Floor	Open Side Door	
	Open Door on the Side Extension	Missing Tiles on the Roof	
	Gaps in the Plywood Roof on the Side Extension	Open Door on the Side Extension	
	Open Front	Gaps in the Door on the Side Extension	
		Open Front

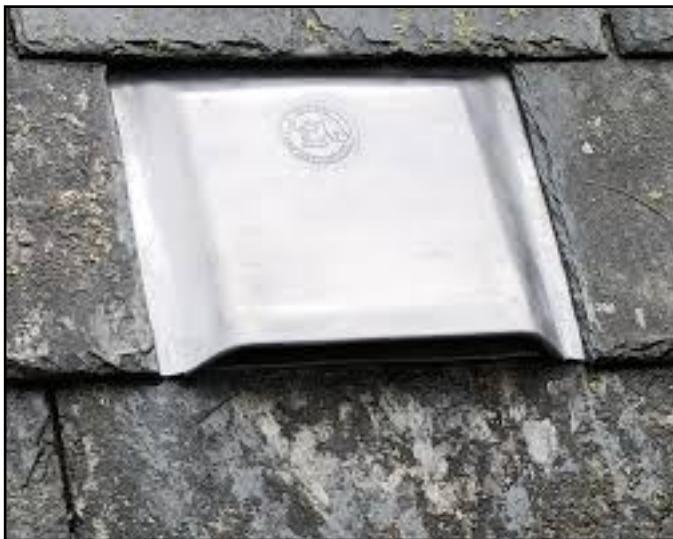
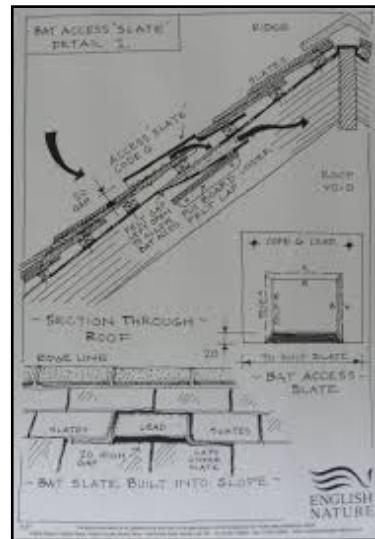
- Horseshoe bats will access the internal roost via a 350x250 open letter box type aperture located in a gable wall. A “L” shaped vertical baffle will be created internally behind the opening to shield the interior from, any external light and bad weather.

- Brown Long Eared bats will access the car port building via 2 bat access slates on each pitch of the roof. Long Eared bats will access the roost above the kitchen area via gaps created behind the barge board on the east gable.

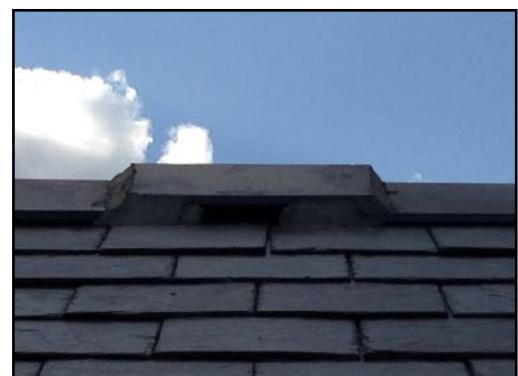
- Crevice dwelling features will be created under raised ridge tiles. One in the middle of the roof and two at each end, located one ridge tile in from the end tile. The raised ridge tiles will be bedded up on mortar which a 100x25mm gap retained for access. The roofing felt will not be cut at the apex. The two end ridge tiles will not have the

ends mortared up, allowing further crevice dwelling access. The entire ridge tile line will have a retained internal linear cavity through out its length with no mortar obscuring this internal cavity.
